INVESTIGATION OF FALL PROTECTION FOR
RESIDENTIAL ROOF CONSTRUCTION AND REPAIR IN HAWAII

A THESIS SUBMITTED TO THE GRADUATE DIVISION OF THE UNIVERSITY
OF HAWAII IN PARTIAL FULFILLMENT OF THE
REQUIREMENTS FOR THE DEGREE OF

CIVIL ENGINEERING

AUGUST 1997

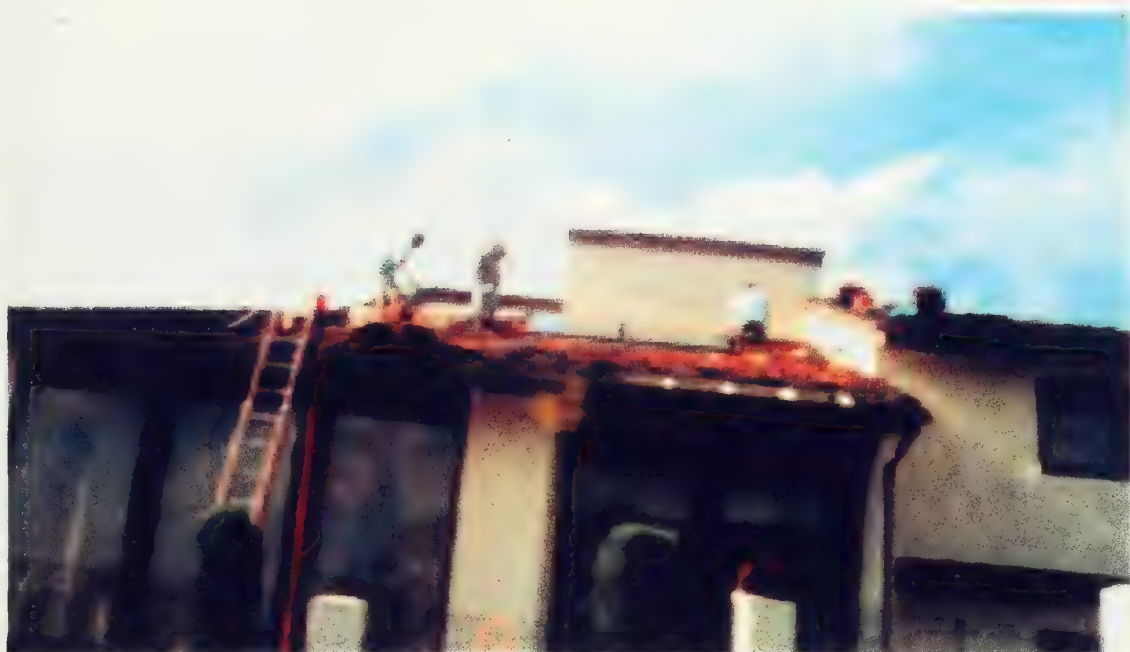
Figure B.1: Partial reroofing project, Aiea; no protection in use

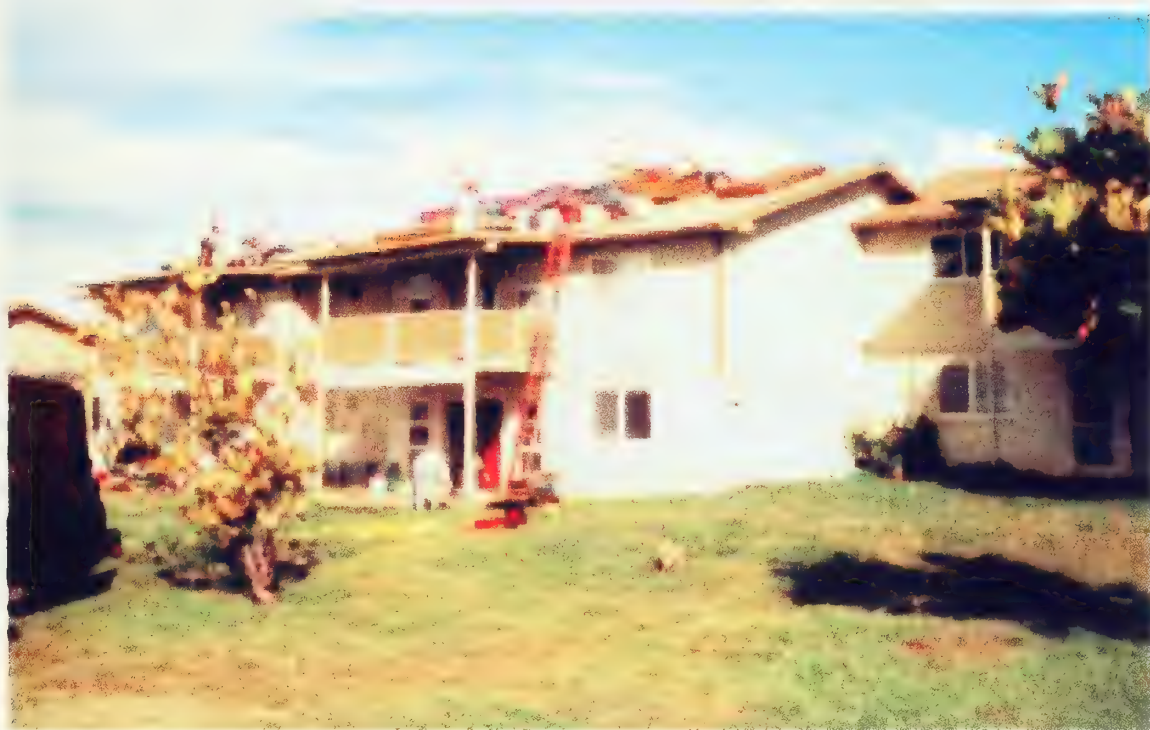
Figure B.2: Reroofing job, Marine Corps Base Hawaii, Kaneohe; PFAS in use

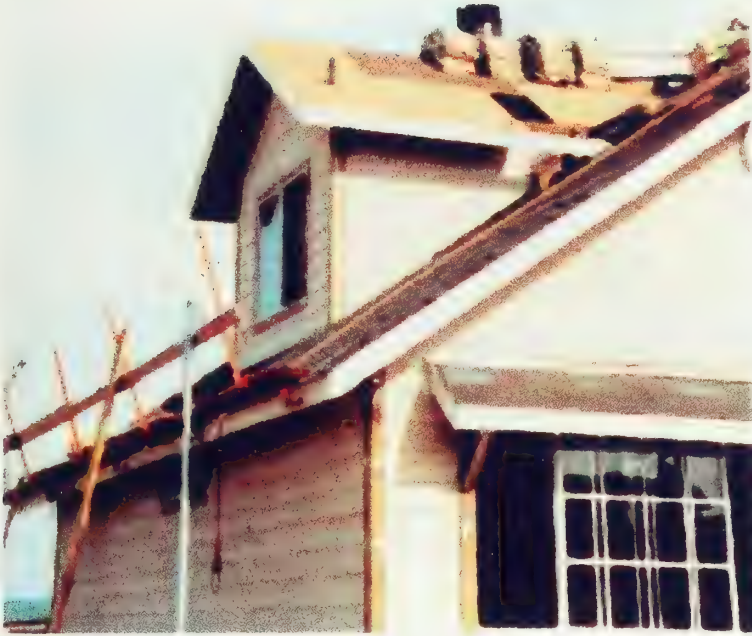
Figure B.5: New construction, Ewa Beach; PR20 Eave Catchguard system and Trus-T PFAS variant, end view

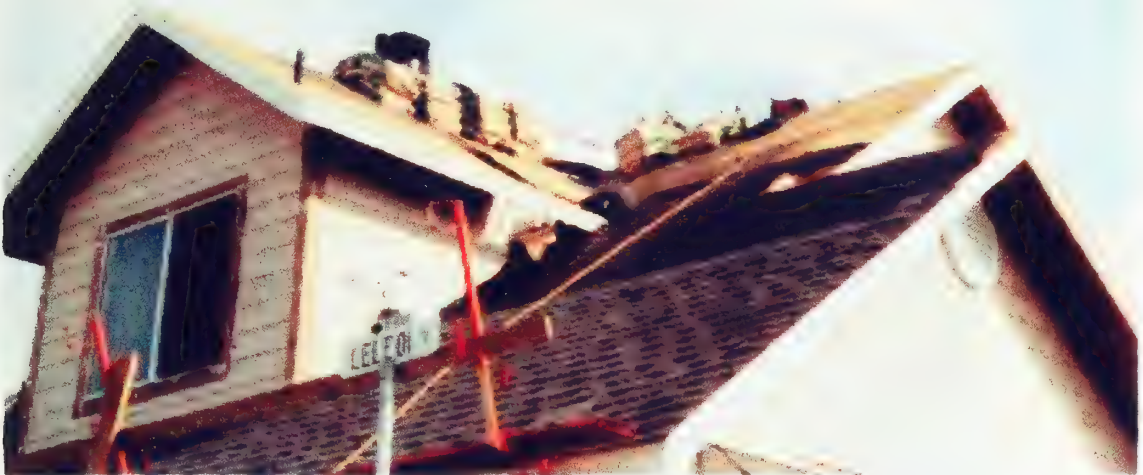
Figure B.6: New construction, Ewa Beach; PR20 Eave Catchguard system and Trus-T PFAS variant, corner view

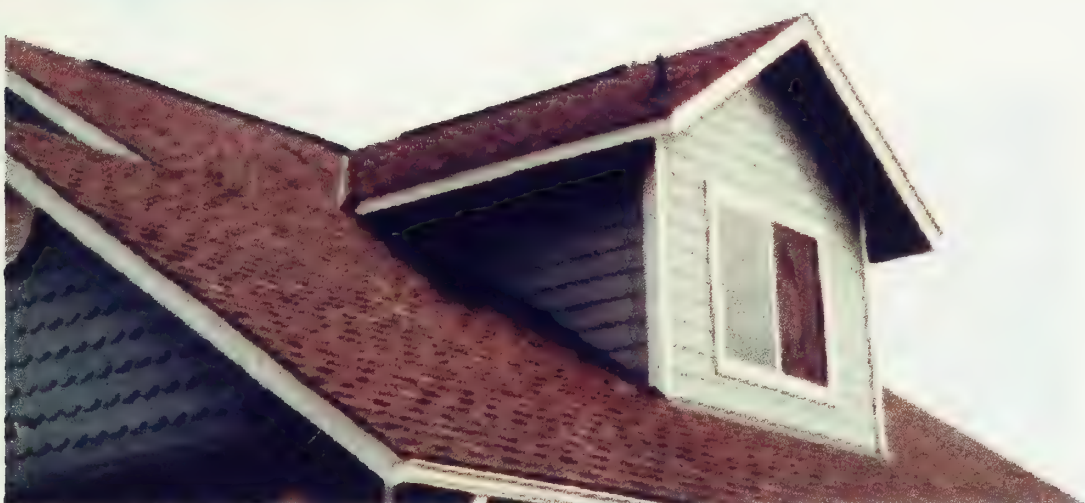
Figure B.7: New construction, Ewa Beach; finished roof with permanent Trus-T anchor system installed on ridge (Note slightly raised portion of ridge cap; Trus-T anchors are spaced evenly along ridge in this raised portion.)

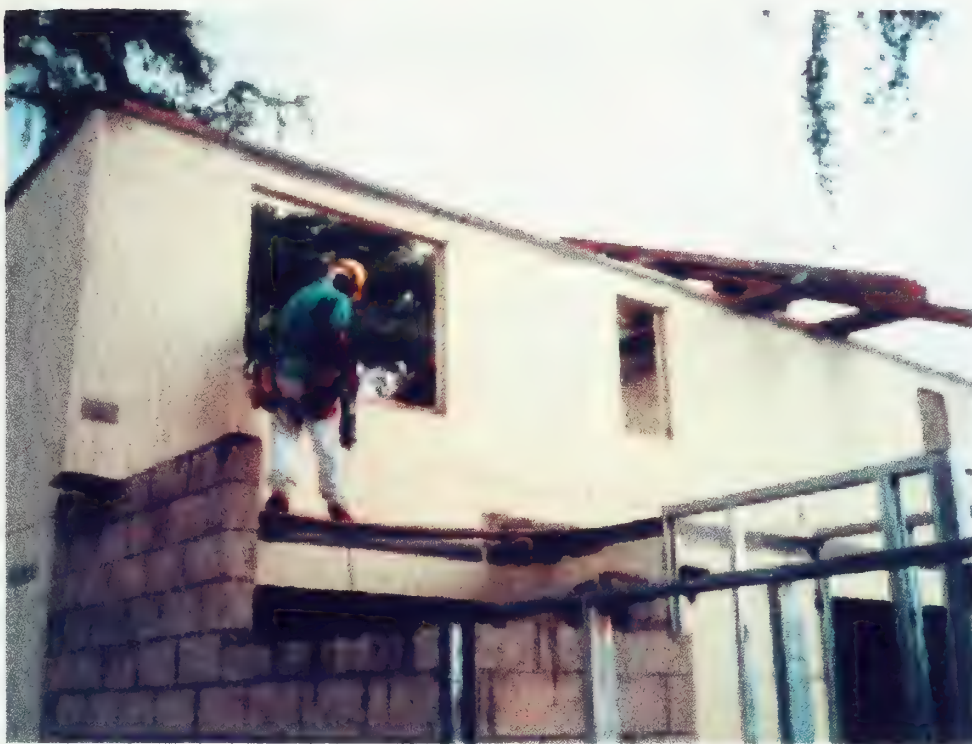
Figure B.8: Renovation project, Hickam Air Force Base; fall protection plan (Note improper work platform and lack of fall protection.)

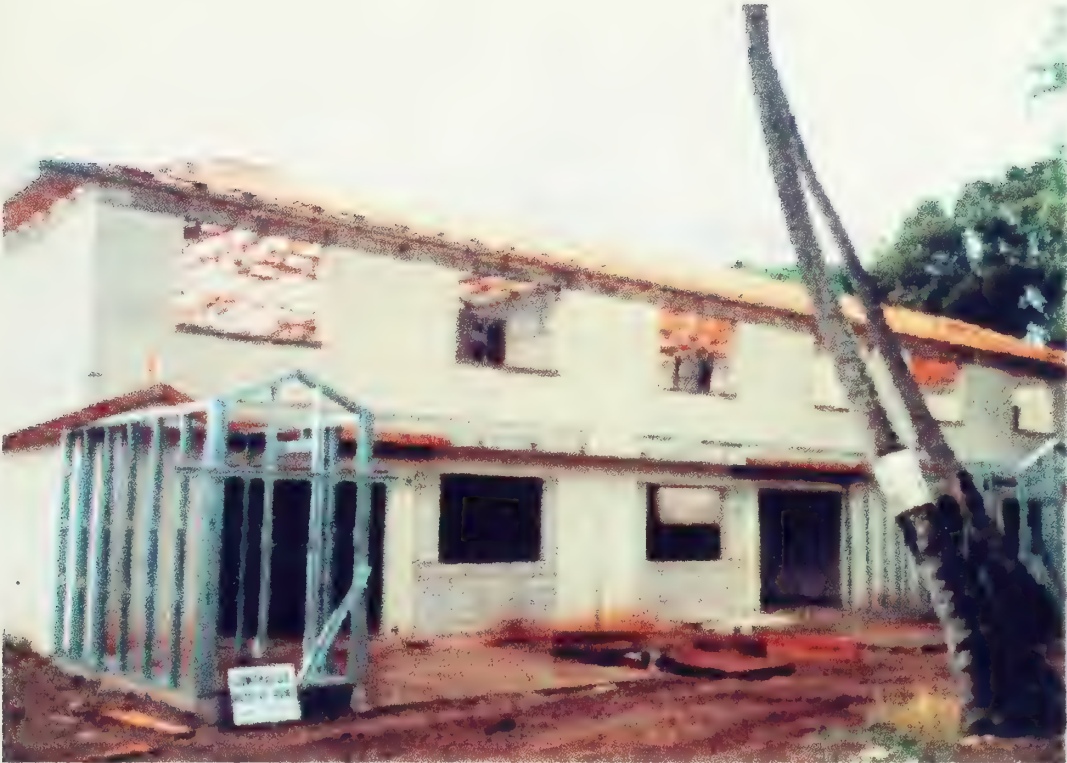
Figure B.9: Renovation project, Hickam Air Force Base; fall protection plan (Note "controlled access zone" sign at left front corner of structure.)

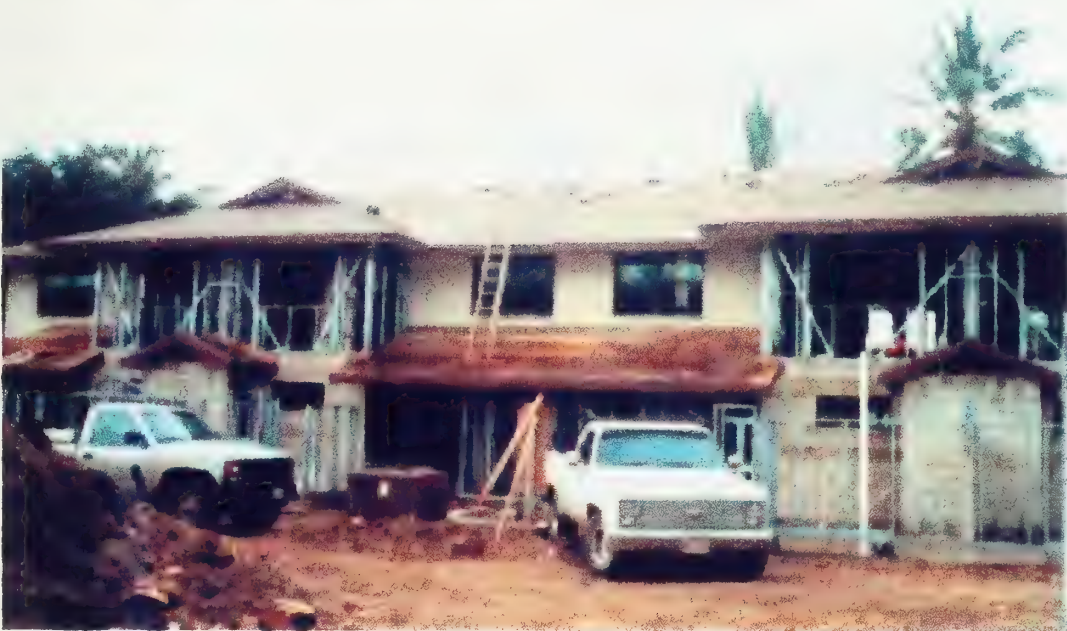
Figure B.10: Renovation project, Hickam Air Force Base; fall protection plan (Note access to roof.)

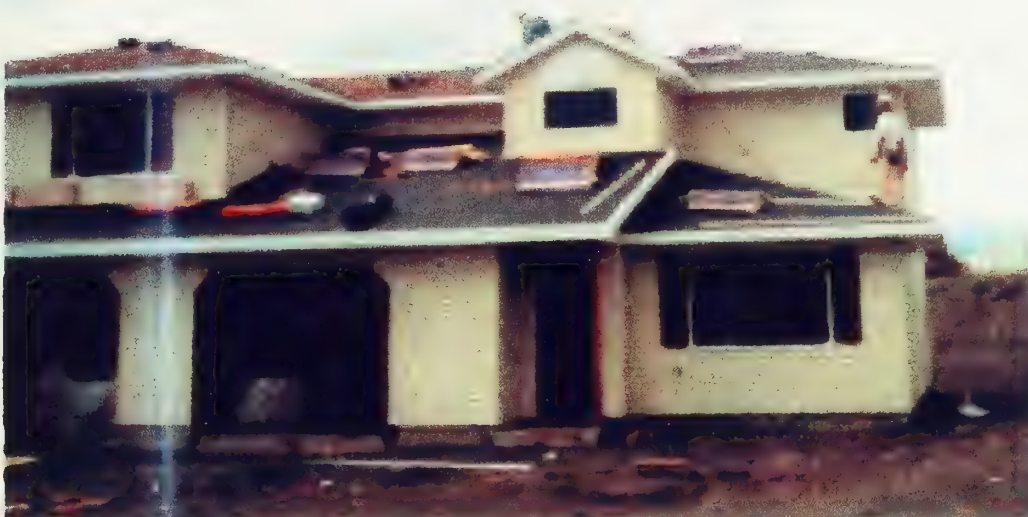
Figure B.11: New construction, Moanalua Navy Family Housing, Pearl Harbor; Safe-T-Strap PFAS variant (Note strap attached to worker's PFAS.)

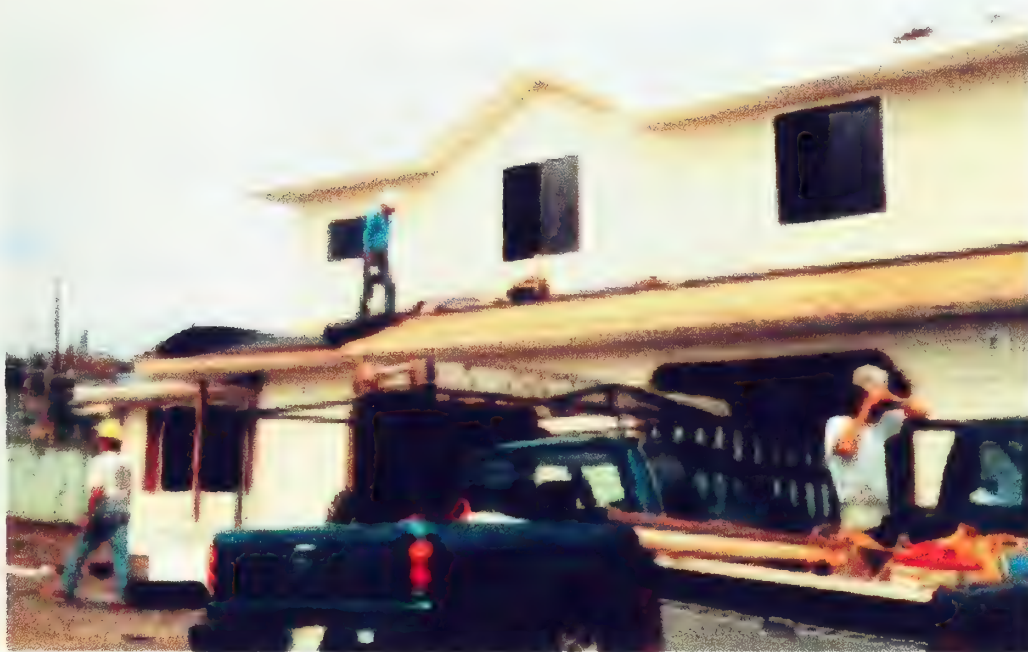
Figure B.12: New construction, Moanalua Navy Family Housing, Pearl Harbor; Safe-T-Strap PFAS variant (Note strap attached to worker's PFAS.)

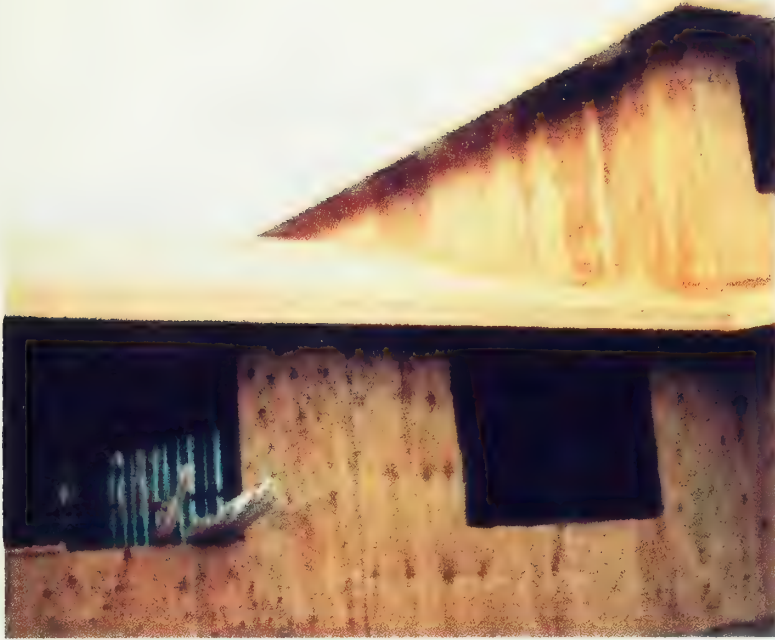
Figure B.13: New construction, Moanalua Navy Family Housing, Pearl Harbor; Safe-T-Strap PFAS variant (Note strap hanging from ridge and proceeding down to right.)

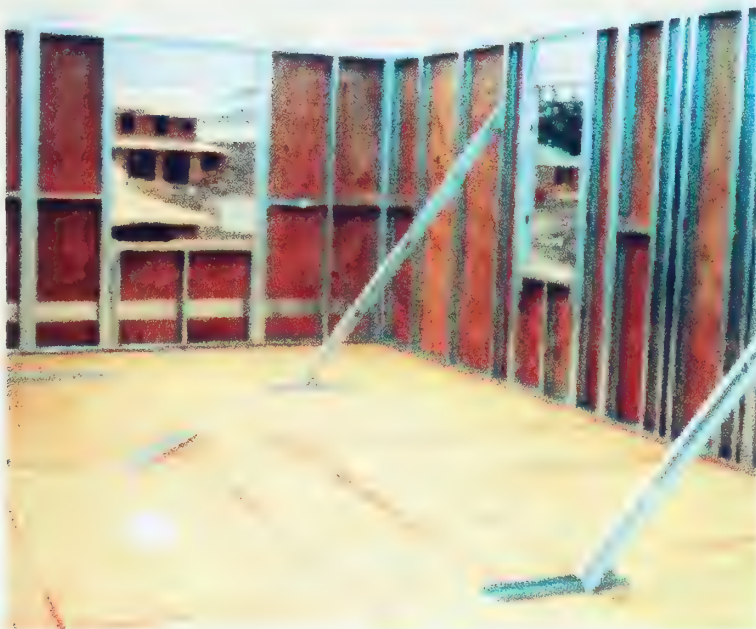
Figure B.14: New construction, Moanalua Navy Family Housing, Pearl Harbor; use of alternative construction sequence to allow for placement of work platforms during truss installation (Note lack of interior frame walls.)

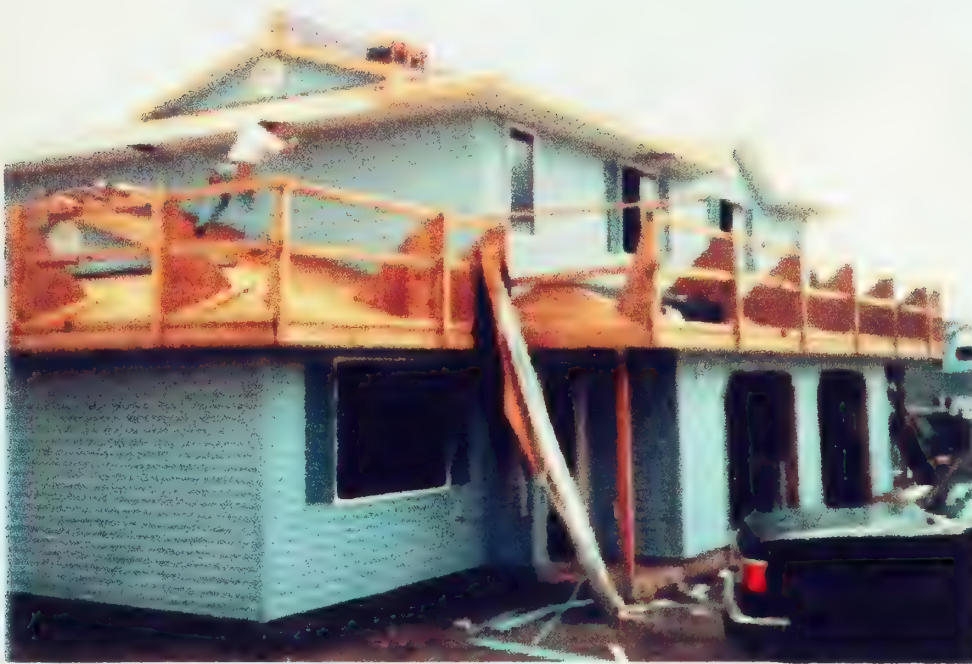
Figure B.15: New construction, Moanalua Navy Family Housing, Pearl Harbor; guardrail system used in siding operations

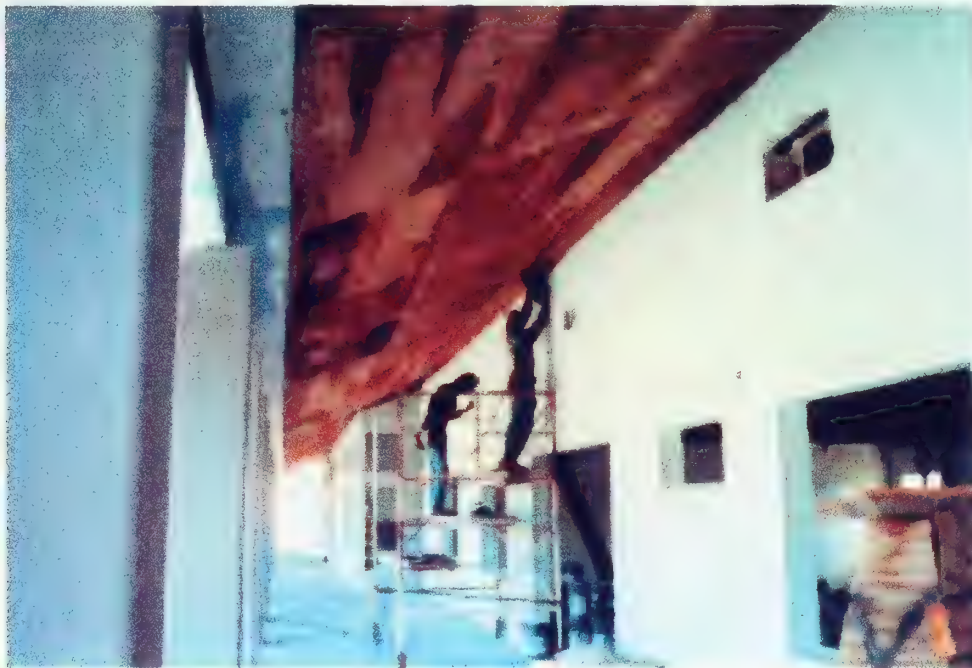
Figure B.16: New construction, Child Development Center, Marine Corps Base Hawaii, Kaneohe; use of scaffolds for finish work

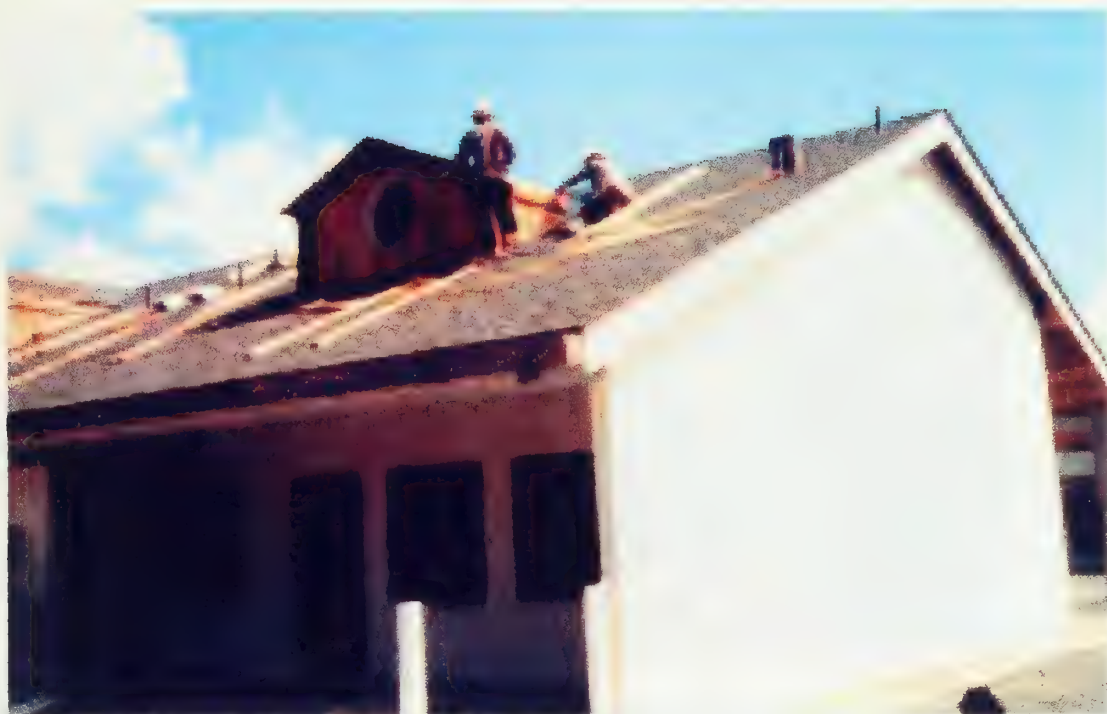
Figure B.17: New construction, Child Development Center, Marine Corps Base Hawaii, Kaneohe; PFAS use (Note the anchorage for the worker's PFAS--a vent pipe!)

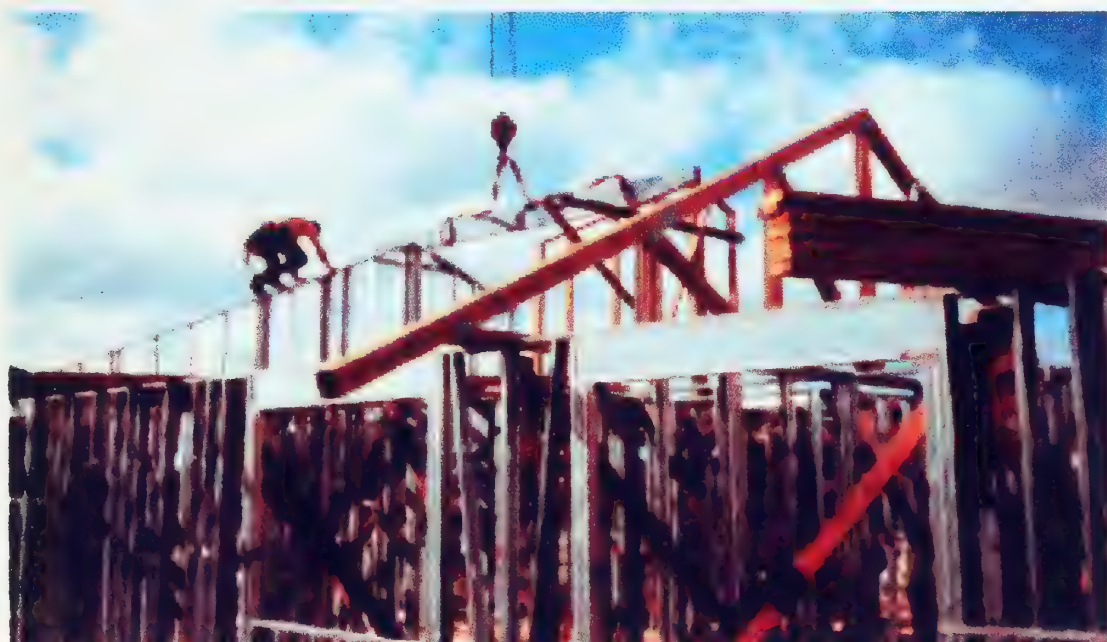
Figure B.18: New construction, central Oahu; fall protection plan; setting the center ridge for half-truss installation (No protection is afforded to the worker.)

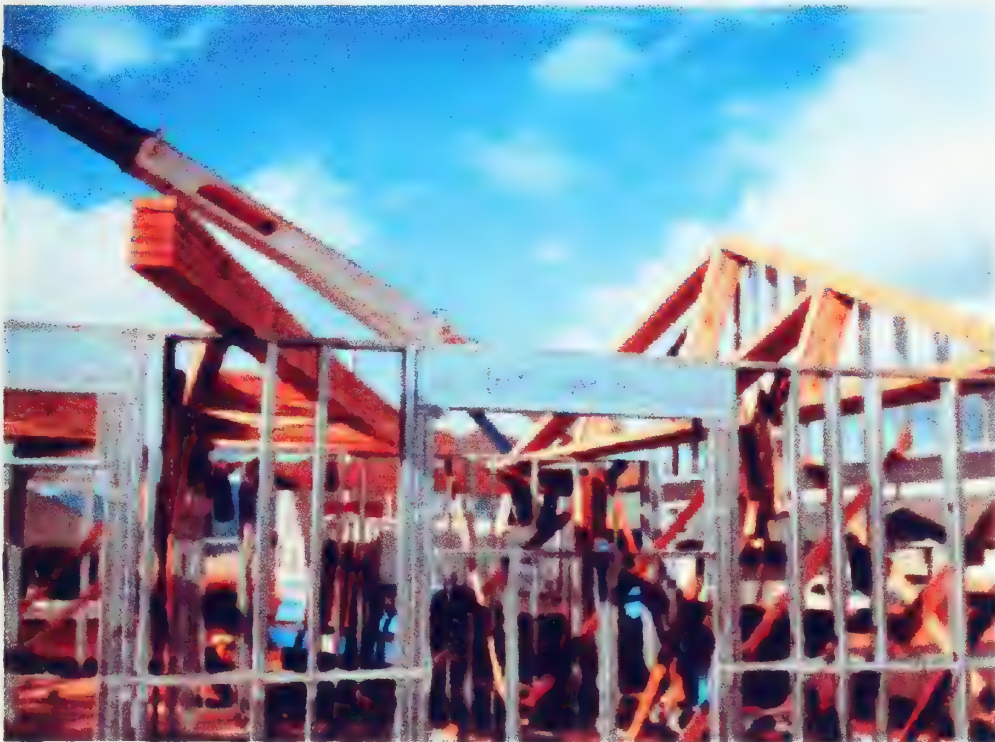
Figure B.20: New construction, central Oahu; fall protection plan; trusses spaced in bundles along top plate for installation by framers

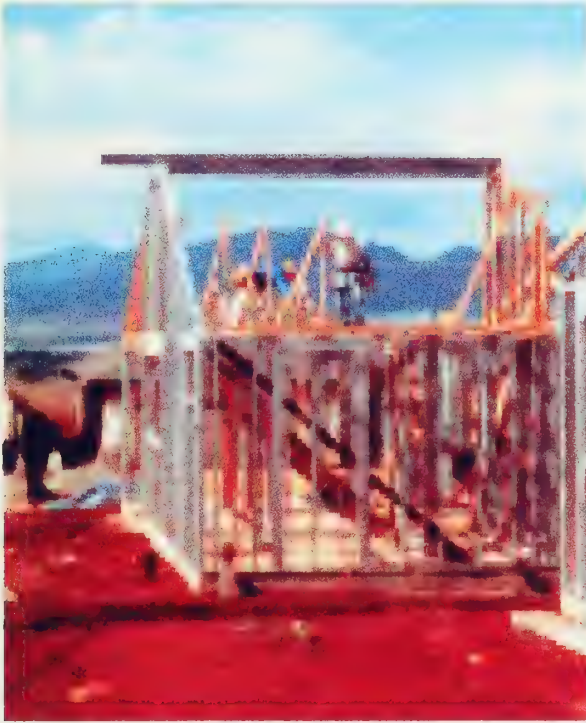
Figure B.21: New construction, central Oahu; fall protection plan; truss installation--setting the trusses

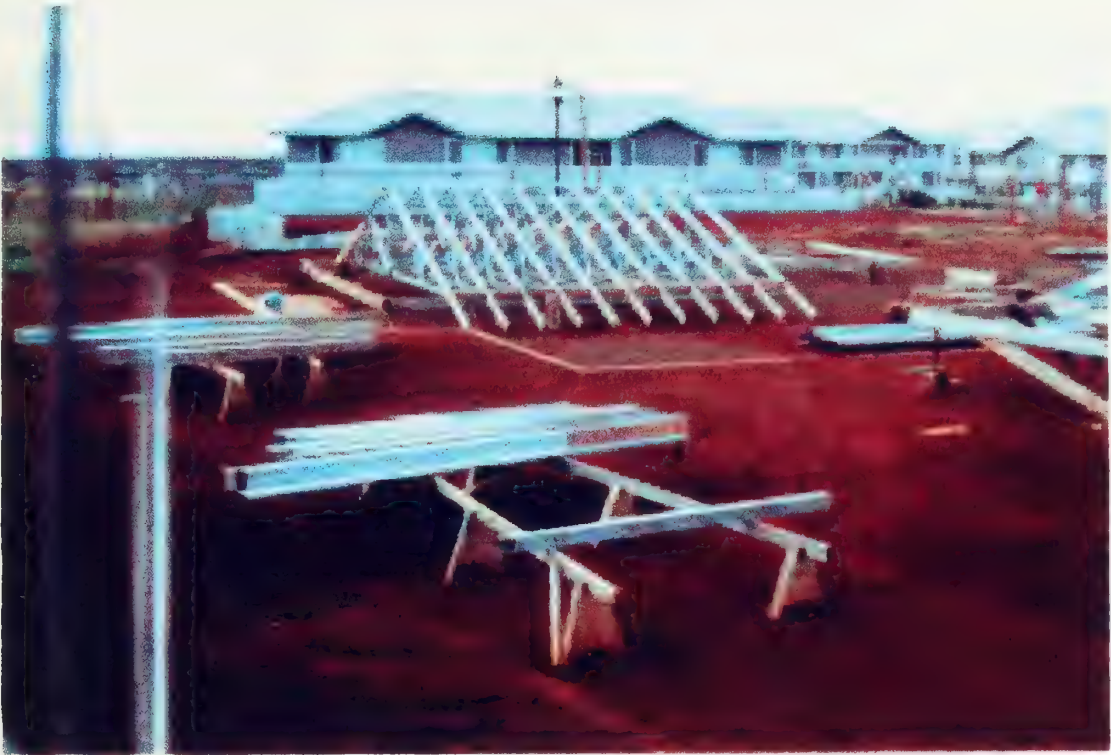
Figure B.27: New construction, central Oahu; prefabrication; prefabricated truss system
